3000-HP ROLLER GEAR TRANSMISSION DEVELOPMENT PROGRAM.
VOLUME V AIRCRAFT TIEDOWN TESTING

3000-HP ROLLER GEAR TRANSMISSION DEVELOPMENT PROGRAM
Volume V - Aircraft Tiedown Testing

Sikorsky Aircraft
Division of United Technologies Corporation
Stratford, Conn. 06602

Final Report

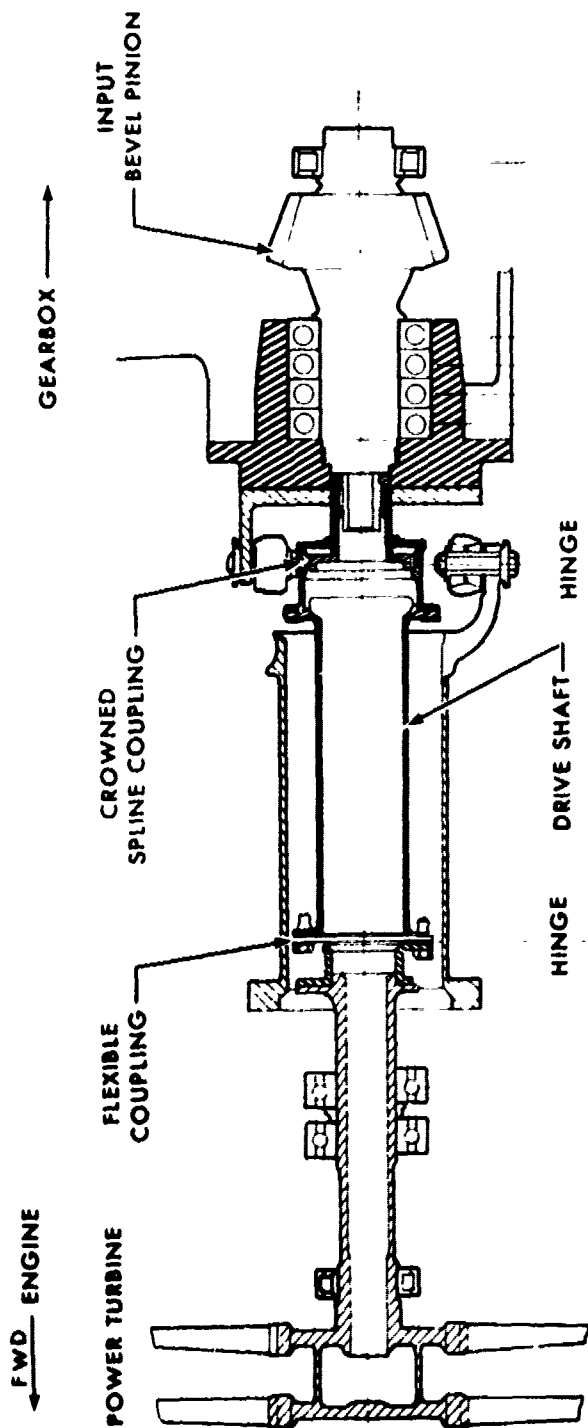
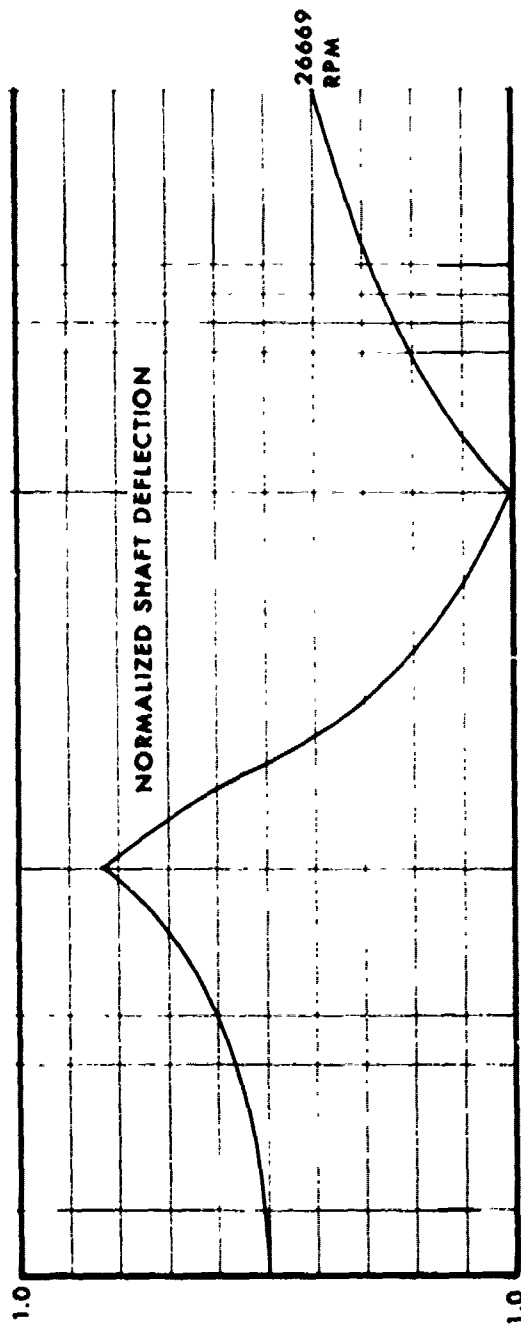
Figure 23. Input Drive Shaft Layout - Critical Speed Analysis

The General Electric Company, manufacturer of the YT58-GE-16 engine, conducted the shake test and found no responses in the engine stator structure to indicate an engine operation vibration problem. However, a high-speed shaft response was found at 22,860 rpm (statically) on the right-hand engine and at 21,960 rpm on the left-hand engine. While these are zero-speed analysis conditions, the frequency is expected to be

higher during actual shaft operation. However, it was recommended that a careful scrutiny be made of the engine vibration levels in the overspeed region and that these shafts be field balanced as found necessary.

It proved to be very difficult to "rap" the engine/transmission high-speed shaft. As can be seen from the drive shaft configuration of Figure 23, the drive shaft is enclosed within the torque tube. Table 5 lists the drive shafts tested and compares their natural frequencies with respect to normal operating frequency. All natural frequencies are well above the 125 percent of maximum operating range; the high-speed shaft, however, will be monitored during tiedown testing.

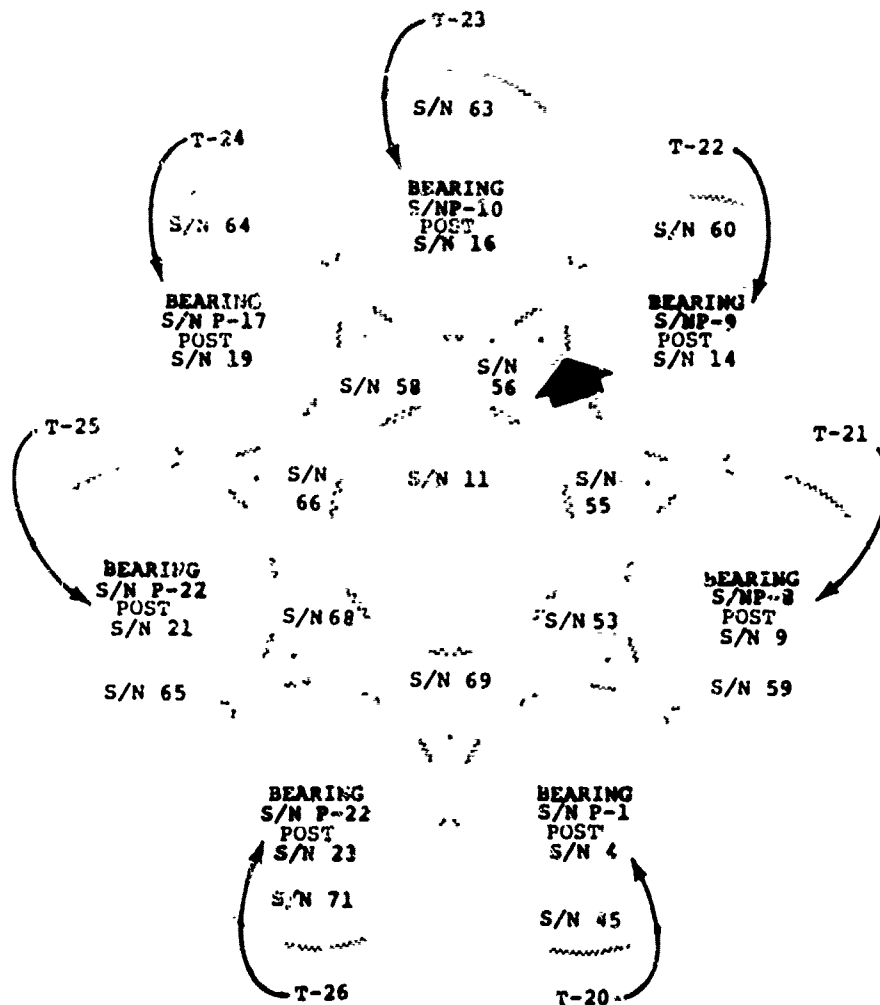
Figure 47. Roller Gear Assembly

Visual inspection of the roller gear components revealed slight surface distress on the lower small-diameter rollers of first-row pinions serial numbers 55 and 56 (Figure 46). As seen from Figure 47, which shows the assembled location of the roller gear components, the identity of the bearings and post within the second-row gear and the appropriate thermocouple (T number), the second-row gear, serial number 60, mated with these pinions. The second-row gear rollers showed only faint markings due to the rolling action with these pinions. Examination of the first-row pinion distressed area revealed a frosted surface approximately 0.12 inch wide around the circumference. This area started on the roller surface where the crown relief of the second-row roller commenced.

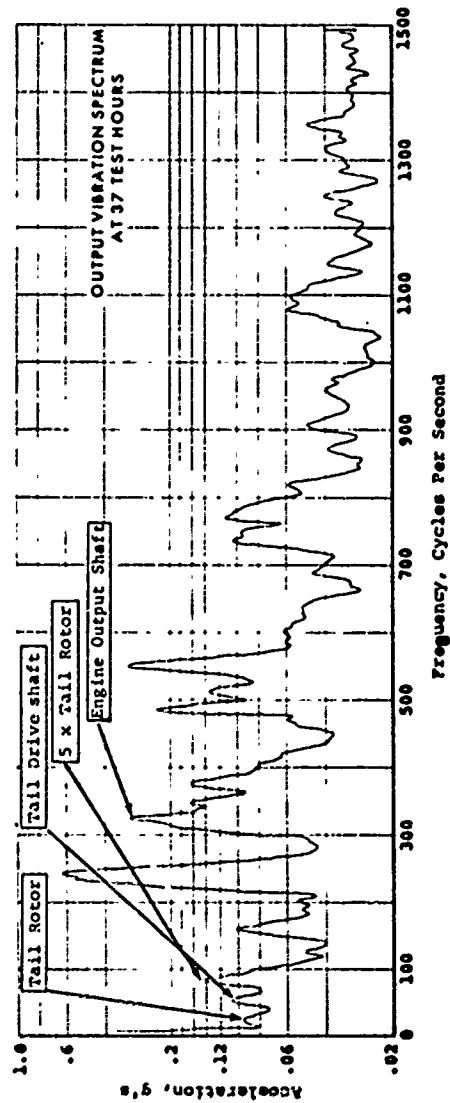
Figure 57. Vibration Spectrum, Tail Rotor Gearbox

Spectrums for the two pickups on the tail gearbox are shown for reference in Figure 57. These spectrums were taken only once during the test. Oscillograph records again showed some variation in the amplitude and character of the waveforms from the tail gearbox pickups which did not appear to be dependent on test time.

The grease in the tail gearbox exhibited a slight darkening with no detectable change in consistency. As in the intermediate gearbox, a substantial amount of lubricant was retained in the gear mesh area. The gearbox is shown with the input housing removed in Figure 59. The gear teeth also showed a film of grease. The teeth evidenced slight scoring as shown. This scoring is not considered to be a serious defect in light of the power levels at which the gearbox was operated.

The input and output gear shafts were magnetic particle inspected, and no crack indications were detected. The bearings were in good condition and showed substantial retained lubricant with no surface damage. The pitch control bearing showed some lubricant staining as well as a general darkening of the grease, but the rolling contact surfaces evidenced no distress. Both the input and output seals were in good condition with no detectable wear or elastomer deterioration.

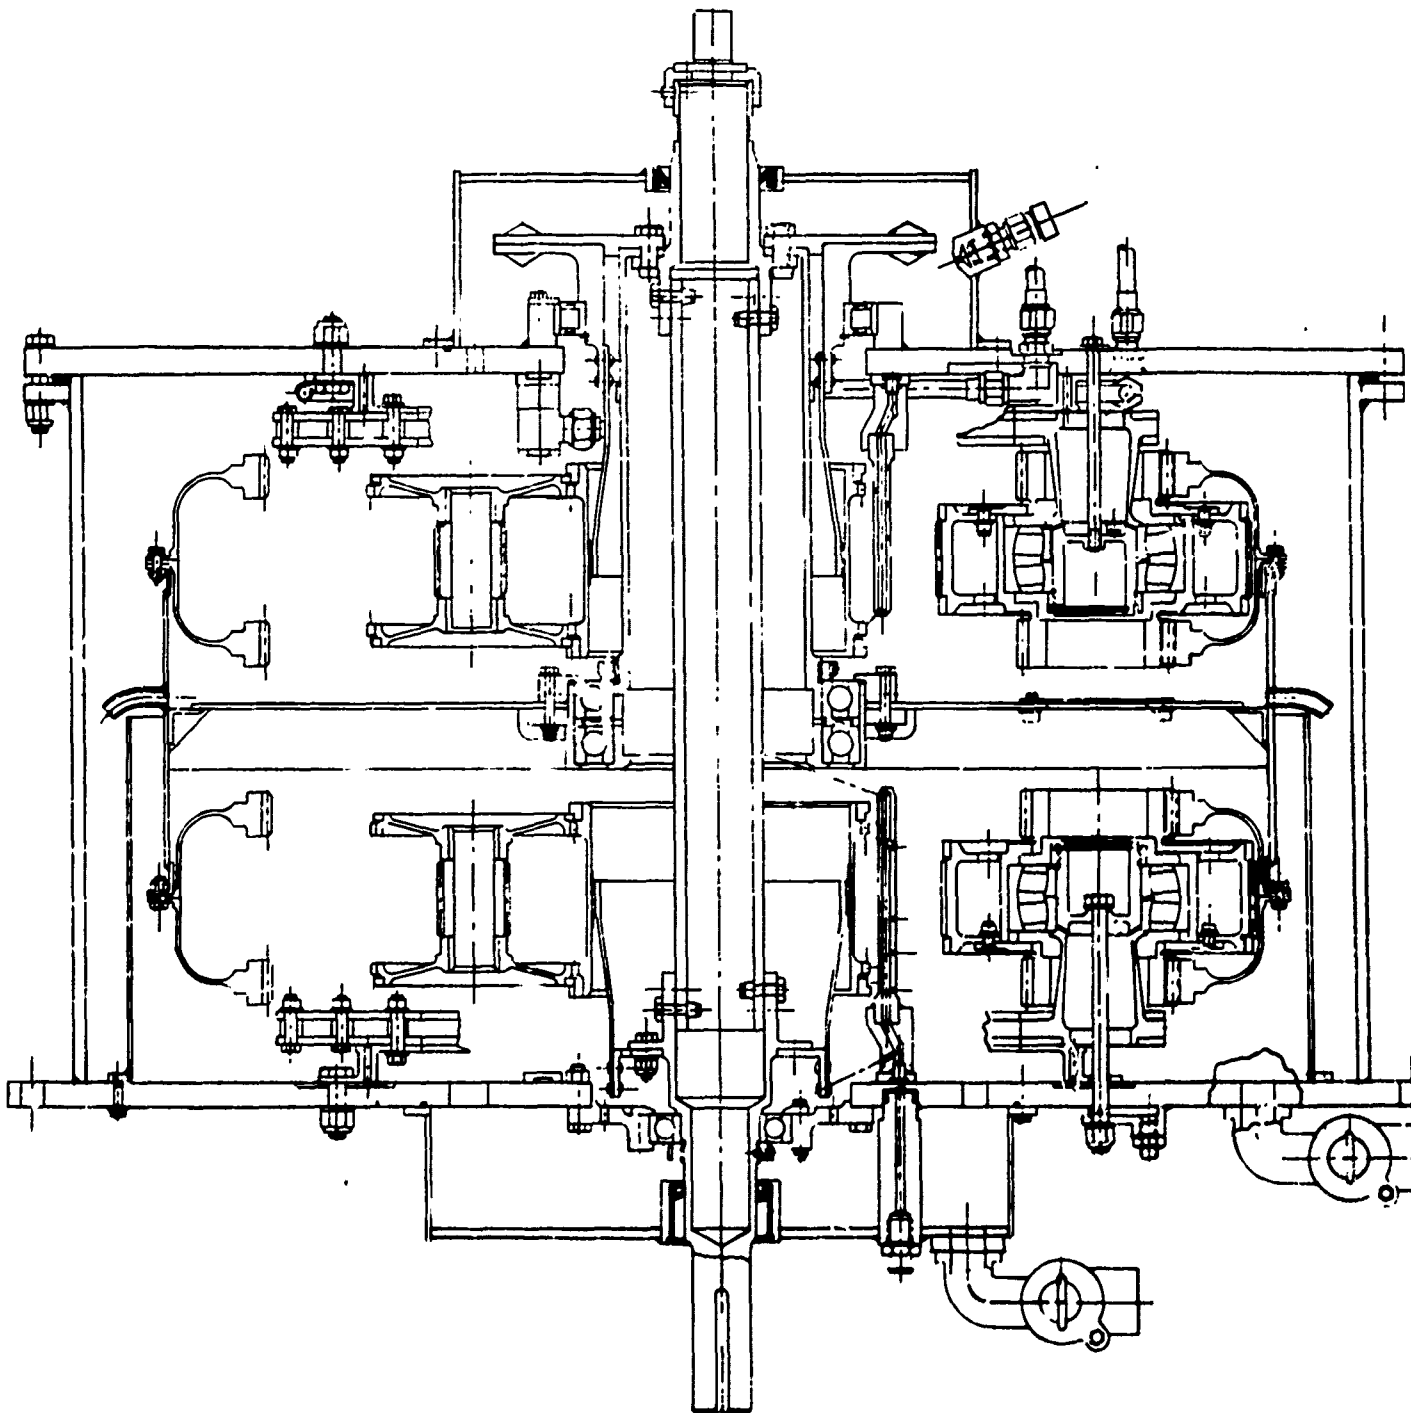
Figure 60. Back-to-Back Roller Gear Test Rig

Further testing was conducted in order to determine the fatigue crack propagation rate of the remaining six second-row gears. This was conducted in a back-to-back test rig which subjects two roller gear units to 3,000 hp at 203 rpm. This facility, depicted in Figure 60, shows two roller gear units supported from the spherical roller bearings in the second-row pinions. The test roller gear is the upper unit; the slave, the lower unit. The input sheave, driven from a 150-hp electric motor, transmits power through the torque tube drive shaft to the upper and lower torque plates, whereby load is statically applied to both roller gear units. Drive is then transmitted to the upper roller gear unit via the quill shaft. The ring gear output of this unit drives the ring gear of the slave and is the input for the lower roller gear unit. The lower quill shaft closes the torque loop by its attachment to the torque tube drive shaft. The torque from each unit is reacted through the spherical bearings of the second-row gears to the stationary posts and hence into the framework of the test rig. Torque is measured and monitored through slip rings from the calibrated strain-gaged torque tube drive shaft.
